Monthly Oversight Report 63
44728 AES [46526 RAC]
ACS NPL Site
Griffith, Indiana
March 4, 2006 – March 31, 2006

Subject: Monthly Oversight Summary Report
No. 63 for March 2006

Monthly Oversight Summary Report No. 63
ACS Superfund Site
TO 057, 44728.238 (AES) [WA57, 46526.238 (RAC)]

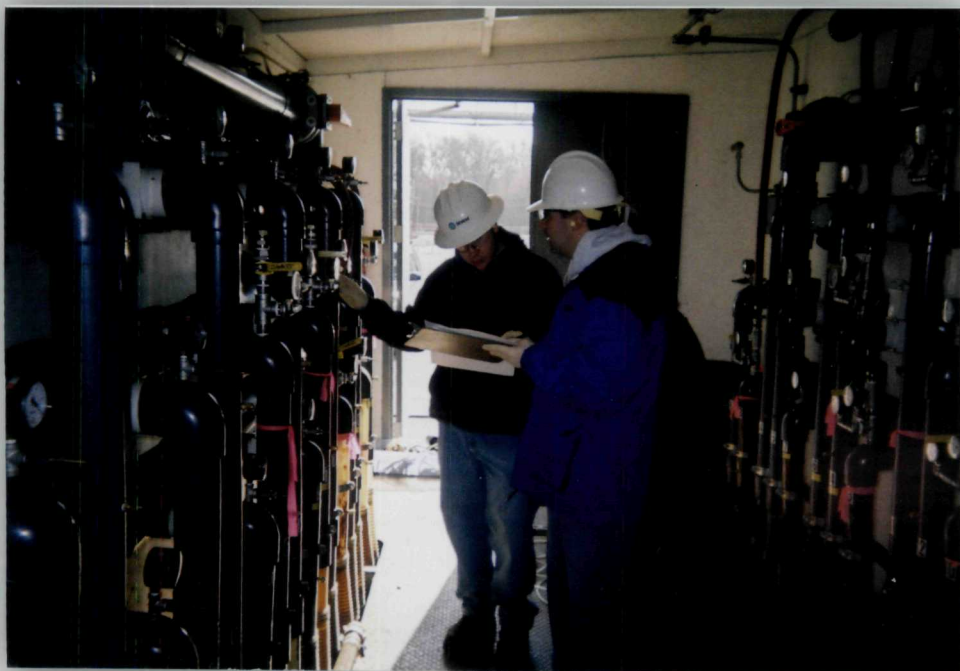
Site: American Chemical Service, Inc.
Proj. #: 44728 AES [46526 RAC]
Roll: 83 Photo #1
Date: 3-15-06 Time: 0911

Description: Photo facing east inside SBPA blower shed showing Chris and Justin observing pressure/vacuum in various SVE lines.

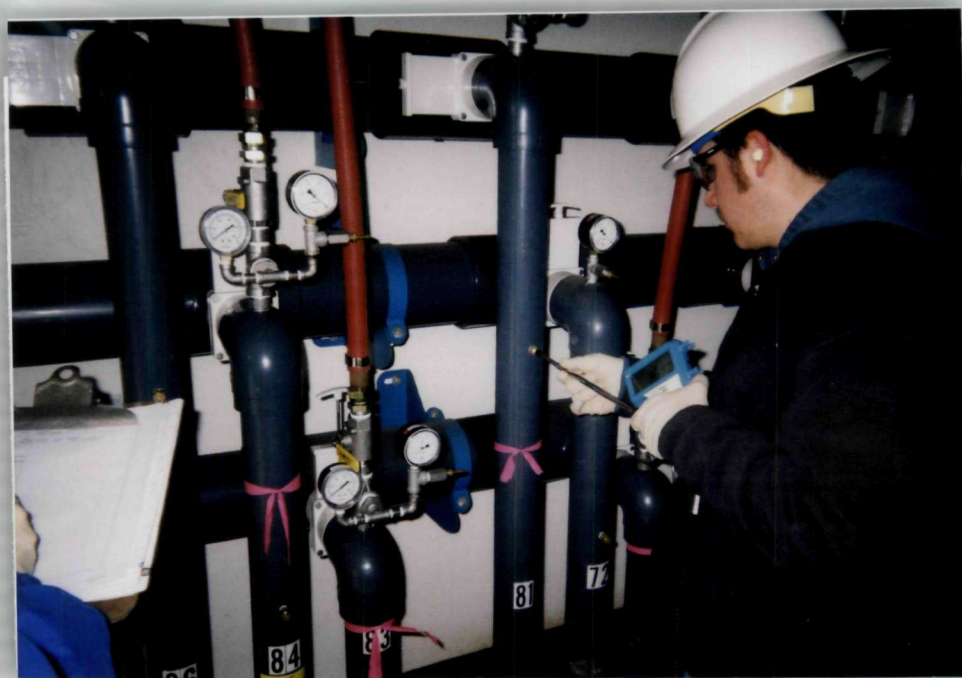
Roll: 83 Photo #2

Description: Photo facing south showing Justin inserting velocity gauge probe into SVE extraction piping line.

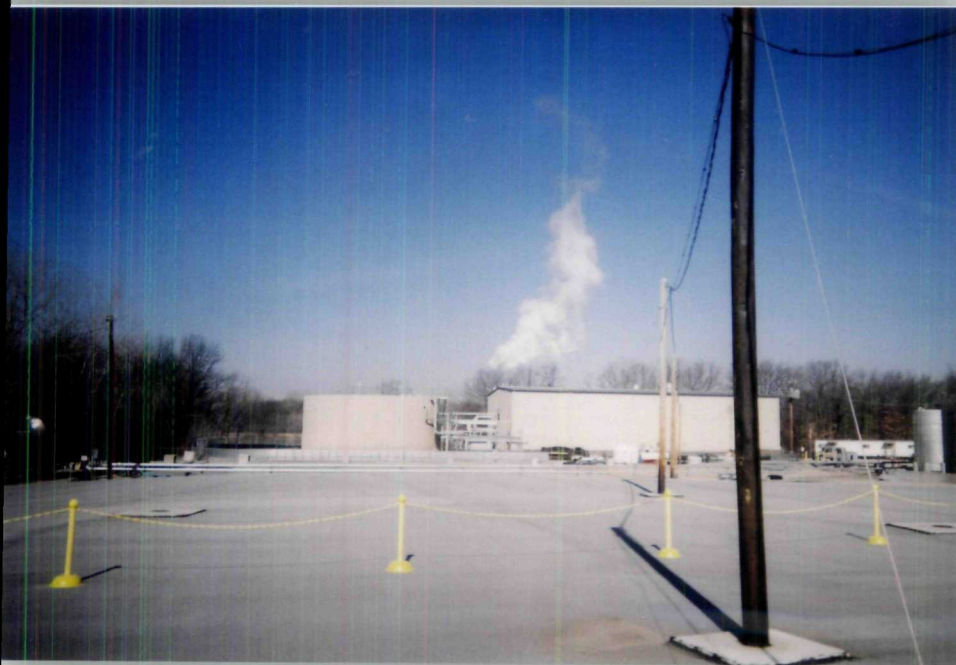
Site: American Chemical Service, Inc.
 Proj. #: 44728 AES [46526 RAC]
 Roll: 83 Photo #3
 Date: 3-15-06 Time: 0929
 Photographer: Larry Campbell
 Description: Photo facing west showing vapor plumes
 from thermox 1 and 2 at GWTP.

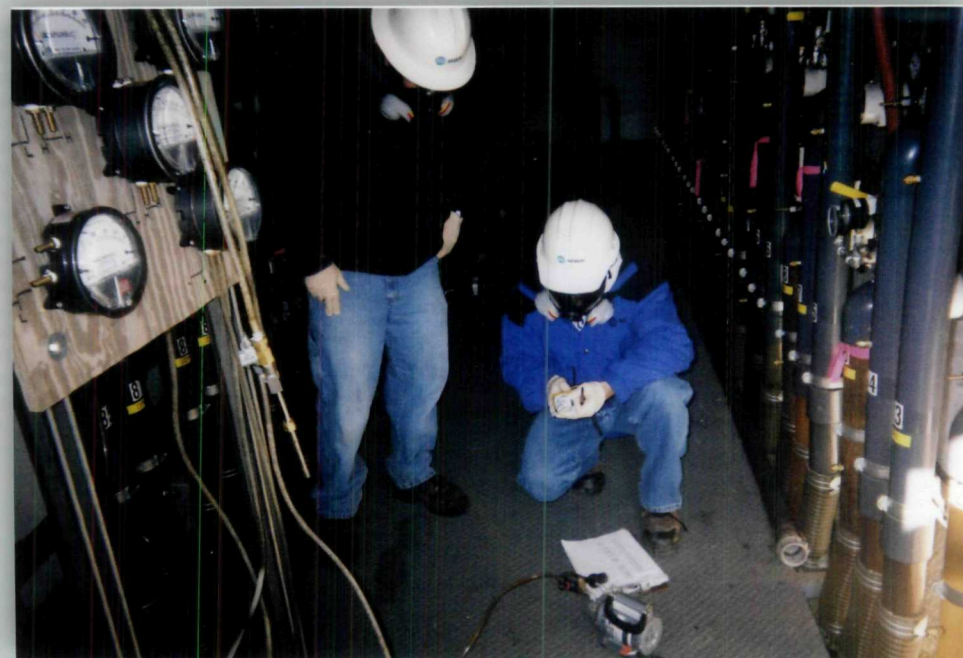
Site: American Chemical Service, Inc.
 Proj. #: 44728 AES [46526 RAC]
 Roll: 83 Photo #4
 Date: 3-15-06 Time: 0950
 Photographer: Larry Campbell
 Description: Photo facing west into SBPA blower shed
 showing MWH measuring contaminant
 loading of SVE influent stream. Note
 crew in air purifying respirators.

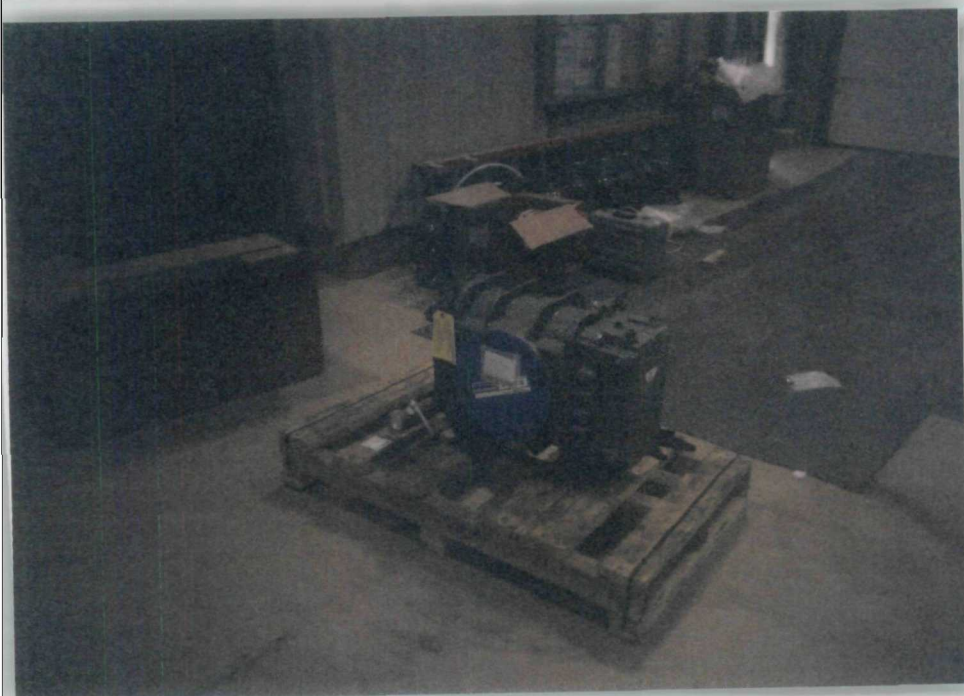
Site: American Chemical Service, Inc.
Proj. #: 44728 AES [46526 RAC]
Roll: 84 Photo #6
Date: 3-28-06 Time: 1040
Photographer: Larry Campbell
Description: Photo facing northwest showing new air pump for ME102. MWH plans to install this new pump today.

MWH reported that blower ME-102 (that provides air to the activated sludge tank and is enclosed in a noise-suppression housing) had failed last year and that it had ordered a new blower and motor. They were delivered in March and will be installed in early April. In the meantime, air is being supplied to the activated sludge tank using blower ME-103, but the noise-suppression housing has not been relocated to cover ME-103.

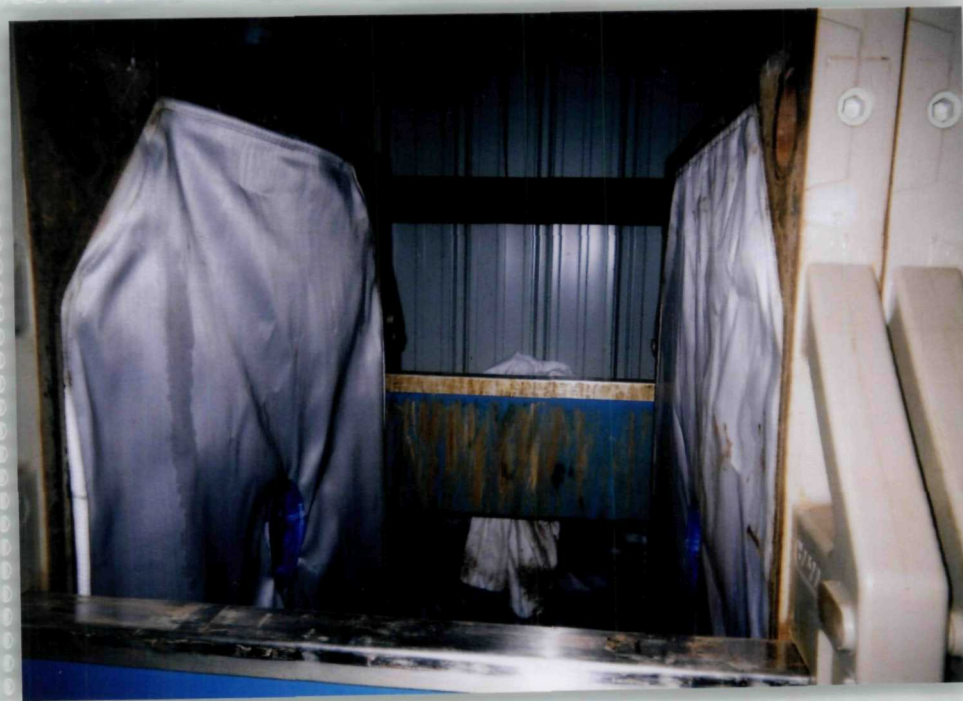
Site: American Chemical Service, Inc.
Proj. #: 44728 AES [46526 RAC]
Roll: 84 Photo #7
Date: 3-28-06 Time: 1042
Photographer: Larry Campbell
Description: Photo facing east showing new filters that were installed on the filter press at the GWTP.

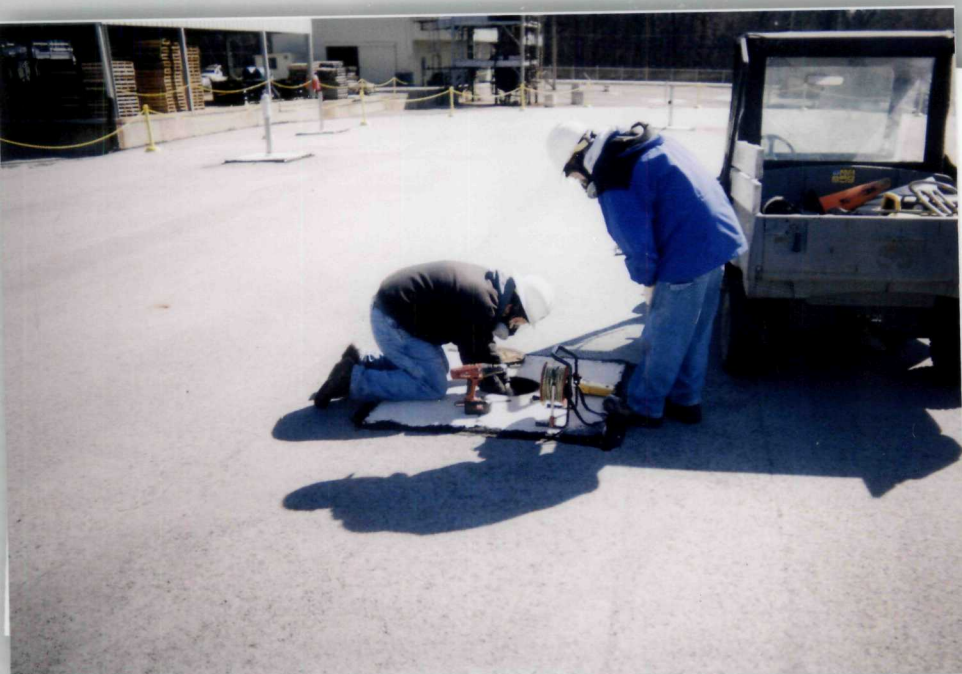
Site: American Chemical Service, Inc.
Proj. #: 44728 AES [46526 RAC]
Roll: 83 Photo #5
Date: 3-15-06 Time: 1031
Photographer: Larry Campbell
Description: Photo facing east showing MWH crew measuring water level in AS-5.

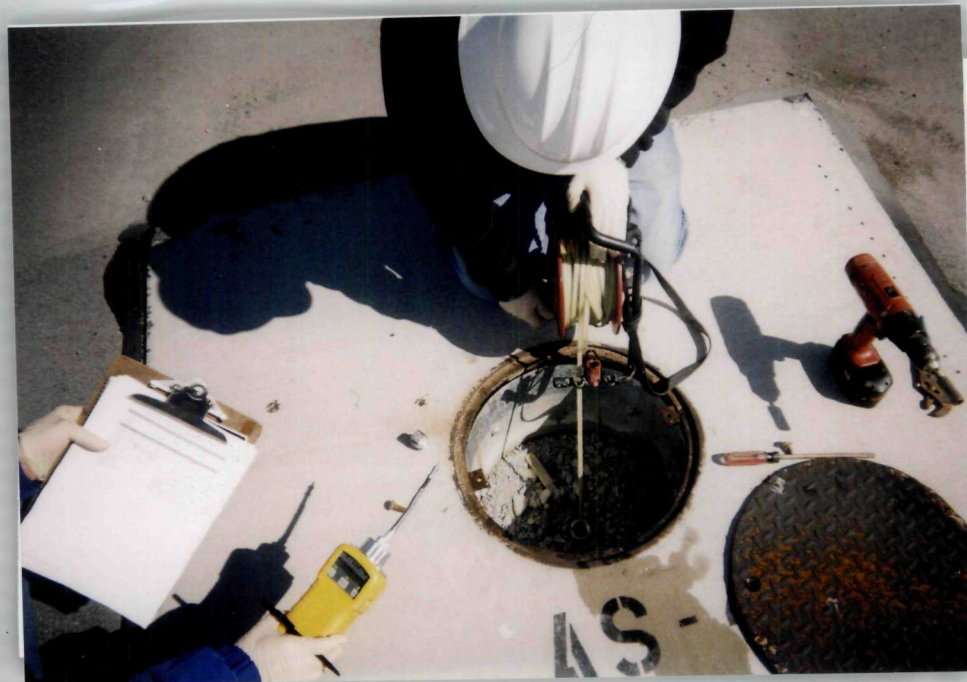
Site: American Chemical Service, Inc.
Proj. #: 44728 AES [46526 RAC]
Roll: 83 Photo #6
Date: 3-15-06 Time: 1038
Photographer: Larry Campbell
Description: Photo facing down into AS-4 showing MWH measuring water level and checking for VOCs with PID.

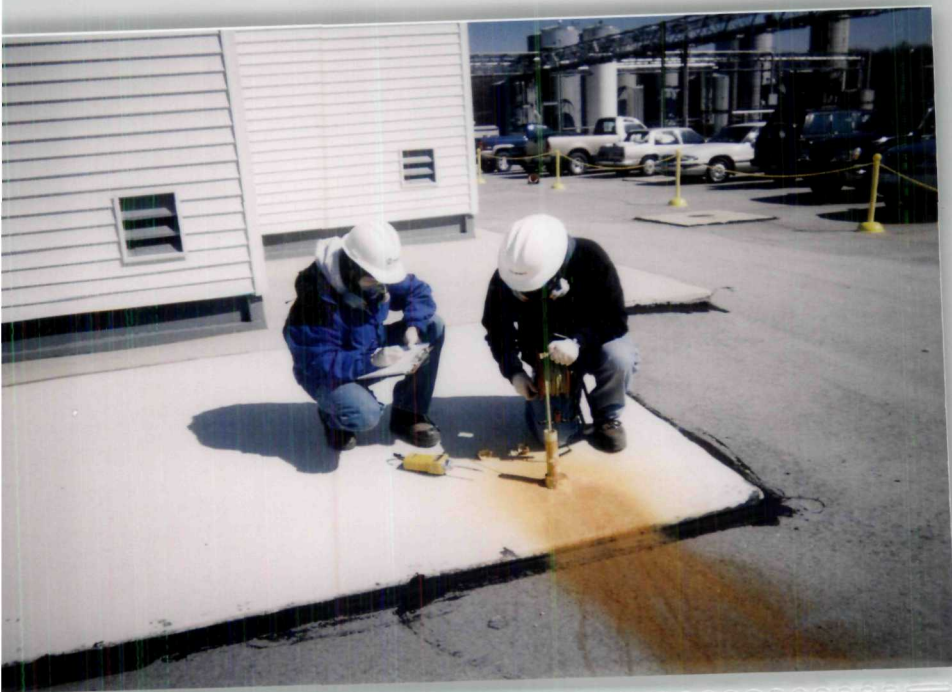
Site: American Chemical Service, Inc.
 Proj. #: 44728 AES [46526 RAC]
 Roll: 83 Photo #7
 Date: 3-15-06 Time: 1058
 Photographer: Larry Campbell
 Description: Photo facing north showing MWH
 measuring water level in SVE-36.

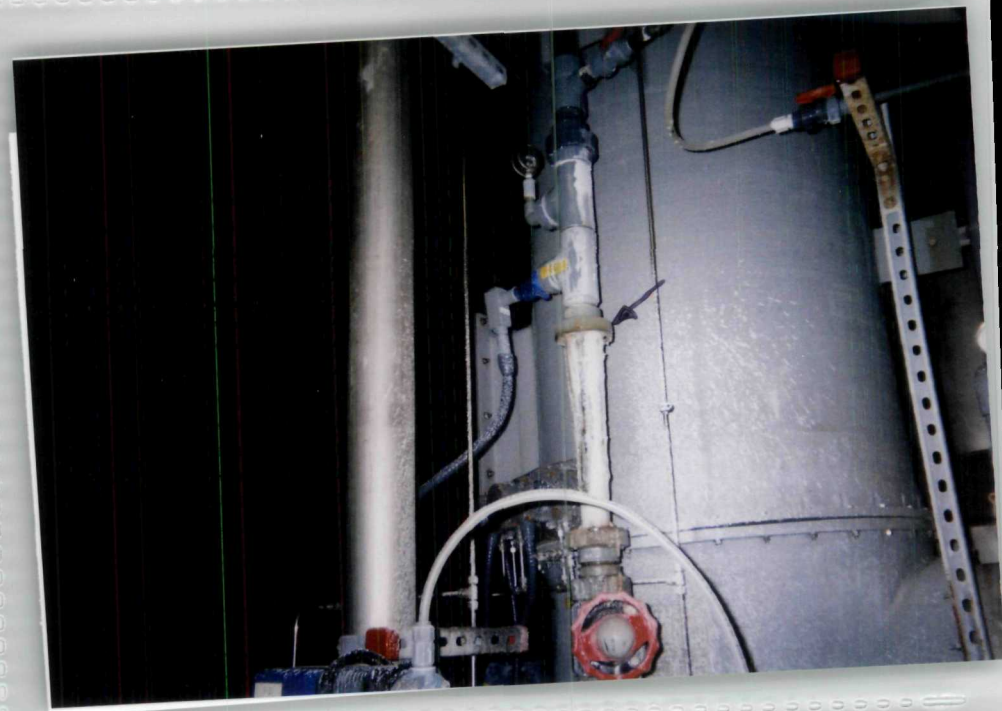
1350 Photo 83-08 looking NE at leaking union on Thormex 2 Acushnet injection piping

Site: American Chemical Service, Inc.
 Proj. #: 44728 AES [46526 RAC]
 Roll: 83 Photo #8
 Date: 3-15-06 Time: 1350
 Photographer: Larry Campbell
 Description: Photo facing northeast showing leaking
 union (arrow) on thermox 2 caustic injection
 piping.

MWH reported repairing a minor caustic leak in thermox 2 on March 15. MWH reported that thermox 2 stopped operating on March 24 because a flexible hose connecting the heat exchanger in tank T-2 ruptured. Thermox 2 was restarted on March 25, but water was not circulated through the heat exchanger in tank T-2. MWH reported that the flexible hose was repaired but the heat exchanger was not restarted since the outside temperature is increasing and additional heating of water for the biotank will not be needed until next fall.

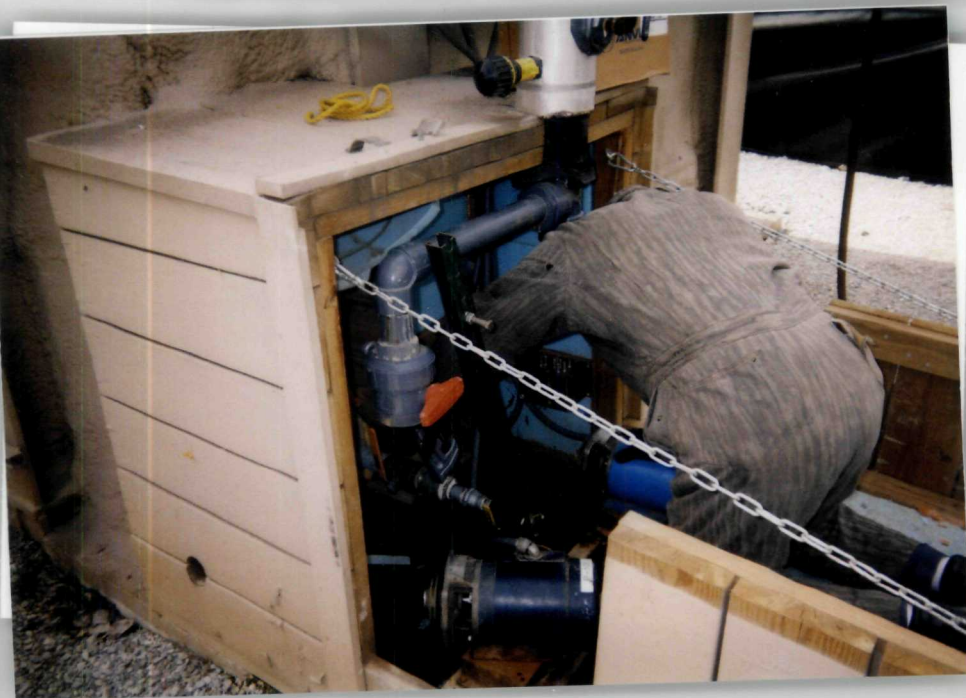
1356 Photo 83-09 looking SW at Tim (Austgen) repairing leak ~~close~~ in equalization tank piping T102

Site: American Chemical Service, Inc.
Proj. #: 44728 AES [46526 RAC]
Roll: 83 Photo #9
Date: 3-15-06 Time: 1356
Photographer: Larry Campbell
Description: Photo facing southwest showing Austgen
repairing clog in equalization tank T-102
influent piping.

MWH reported that the GWTP was shut down for a few hours on March 15 in order to install new influent piping to the equalization tank T-102, replacing the piping that had been partially clogged. MWH reported that the water level sensor failed in equalization tank T-102 on March 16, allowing

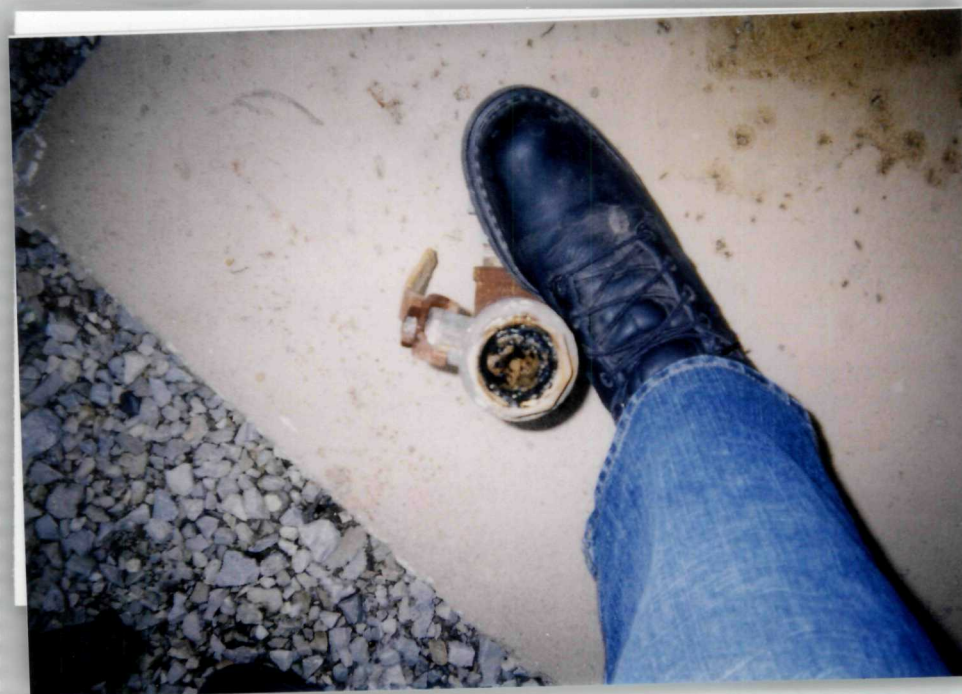
Site: American Chemical Service, Inc.
Proj. #: 44728 AES [46526 RAC]
Roll: 83 Photo #10
Date: 3-15-06 Time: 1401
Photographer: Larry Campbell
Description: Photo facing down showing clogged 1.5-
inch-diameter piping removed from
equalization tank T-102 influent.

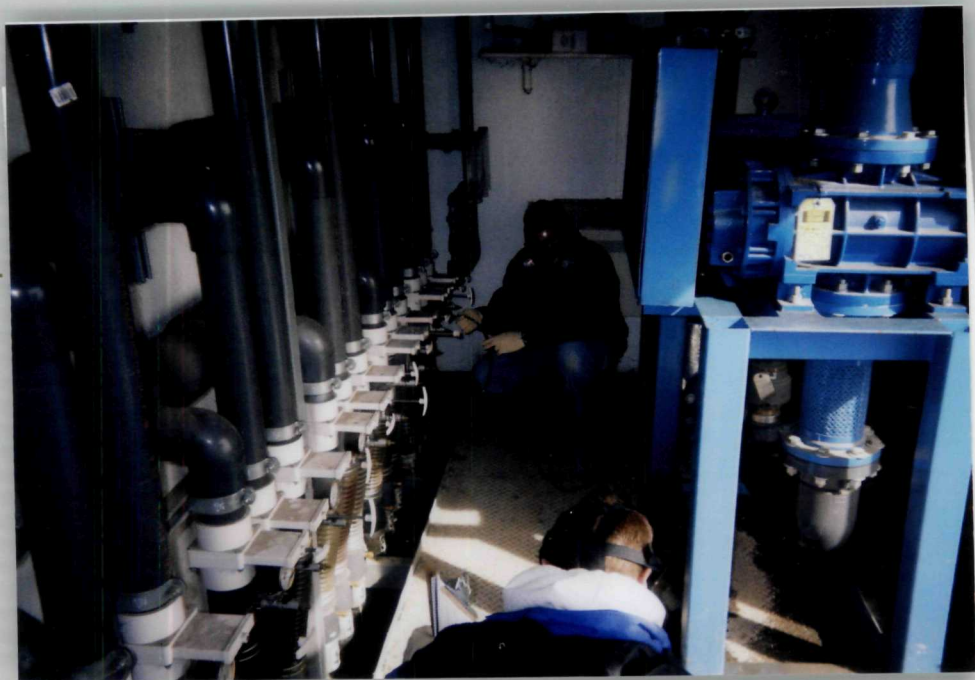
Site: American Chemical Service, Inc.
 Proj. #: 44728 AES [46526 RAC]
 Roll: 83 Photo #11
 Date: 3-15-06 Time: 1425
 Photographer: Larry Campbell
 Description: Photo facing east inside OFCA blower shed
 showing MWH measuring VOC
 concentration in OFCA SVE lines. Note
 APRs.

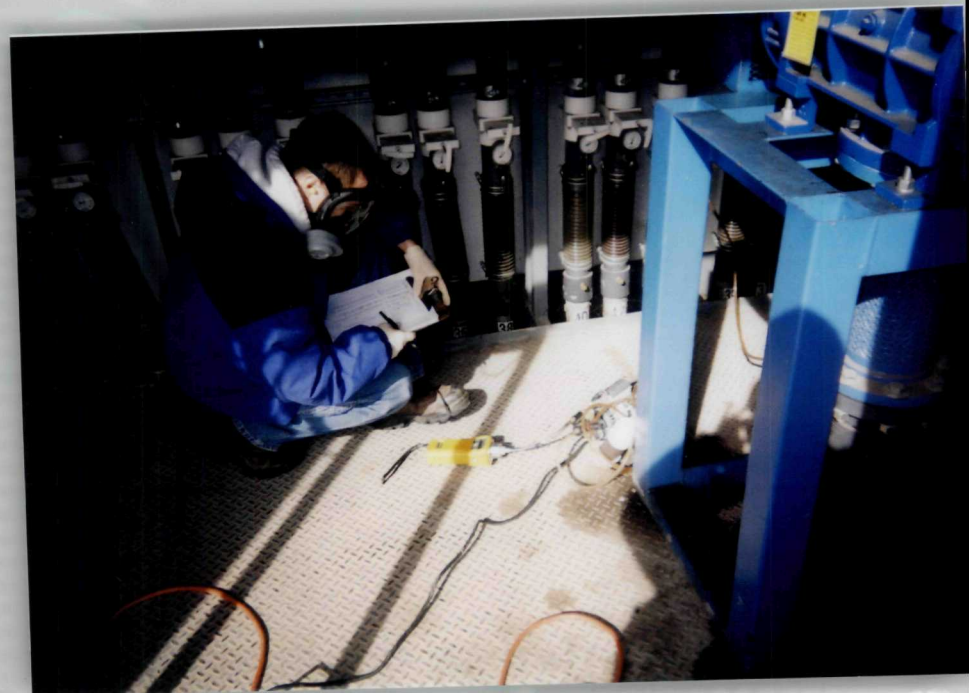
Site: American Chemical Service, Inc.
 Proj. #: 44728 AES [46526 RAC]
 Roll: 83 Photo #12
 Date: 3-15-06 Time: 1428
 Photographer: Larry Campbell
 Description: Photo facing north into OFCA blower shed
 showing MWH measuring VOCs with PID.

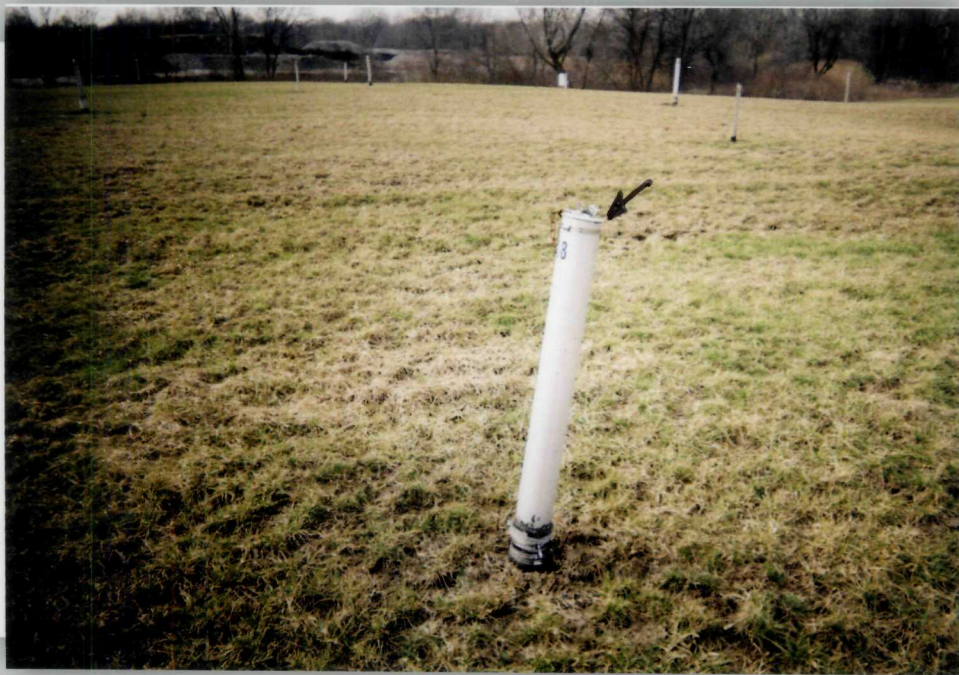
1446 Photo 83-13 looking W at OFCA SVE 38. Vacuum cap is leaking air Also to looking

Site: American Chemical Service, Inc.
Proj. #: 44728 AES [46526 RAC]
Roll: 83 Photo #13
Date: 3-15-06 Time: 1446
Photographer: Larry Campbell
Description: Photo facing west showing OFCA SVE38.
Vacuum cap is leaking air. Same condition
observed at SVE40.

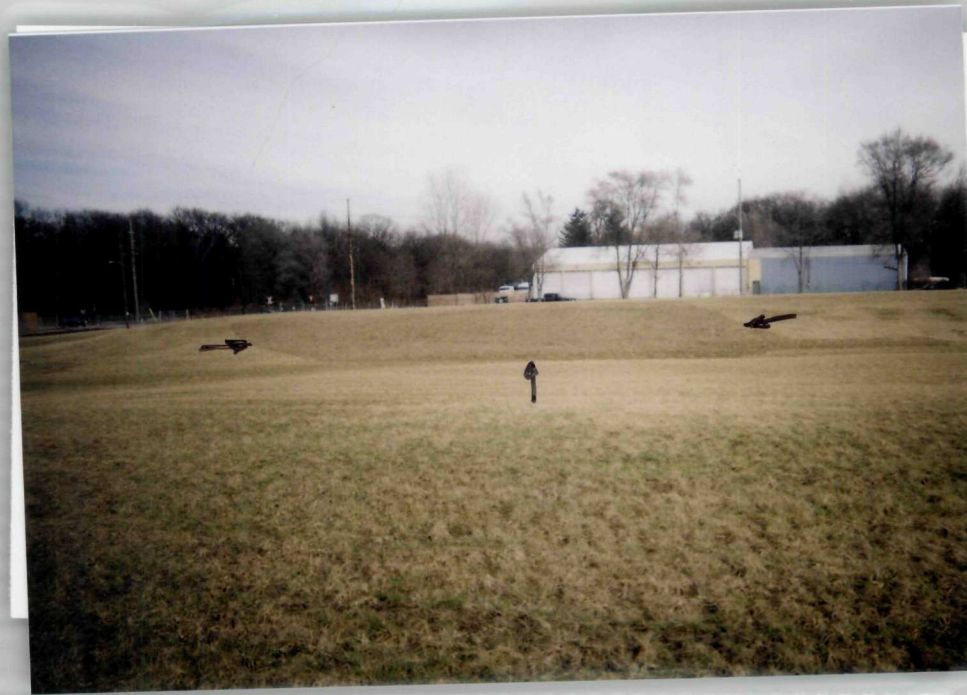
Site: American Chemical Service, Inc.
Proj. #: 44728 AES [46526 RAC]
Roll: 83 Photo #14
Date: 3-15-06 Time: 1448
Photographer: Larry Campbell
Description: Photo facing east showing reseeded area on
east side of OFCA where trees cut from
OFCA had been staged. Area was
reseeded later than adjacent areas.

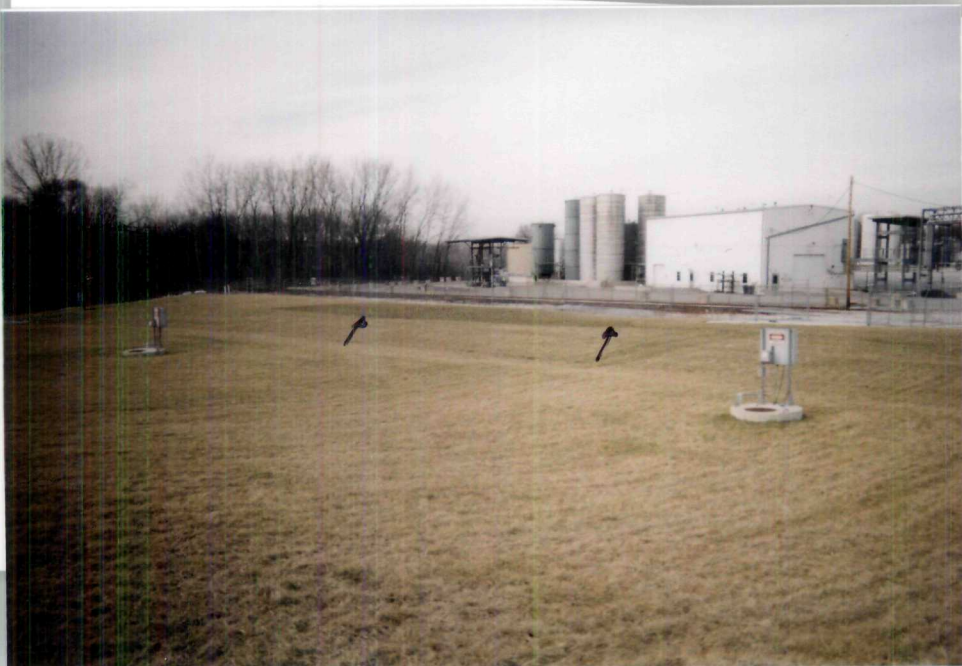
Description: Photo facing northwest showing reseeded area on north side of OFCA where trees cut from OFCA had been staged. Area was reseeded later than adjacent areas.

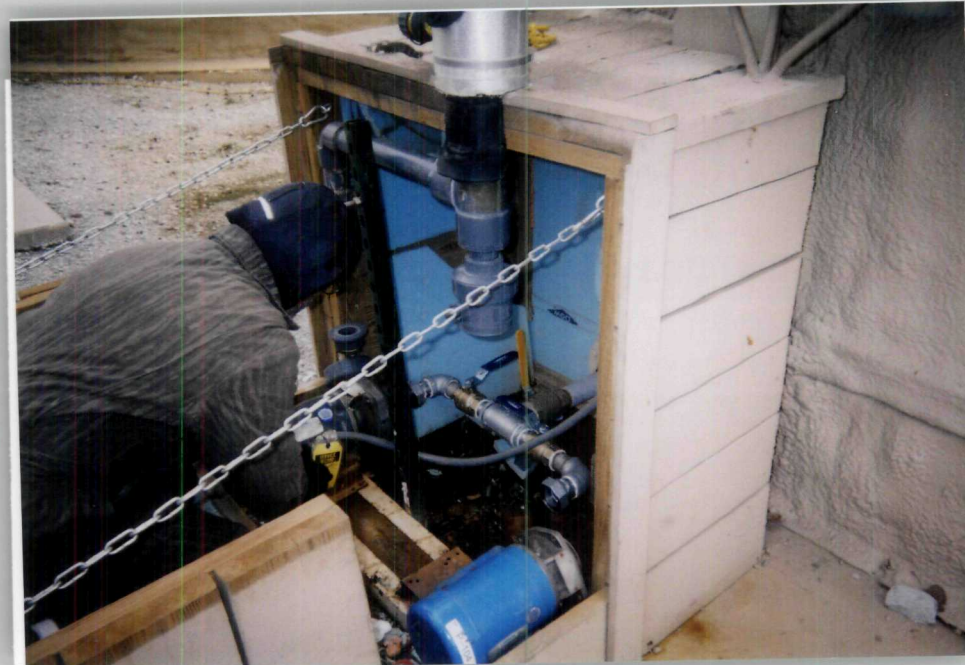
Description: Photo facing southeast showing new influent pipes installed at equalization tank T-102.

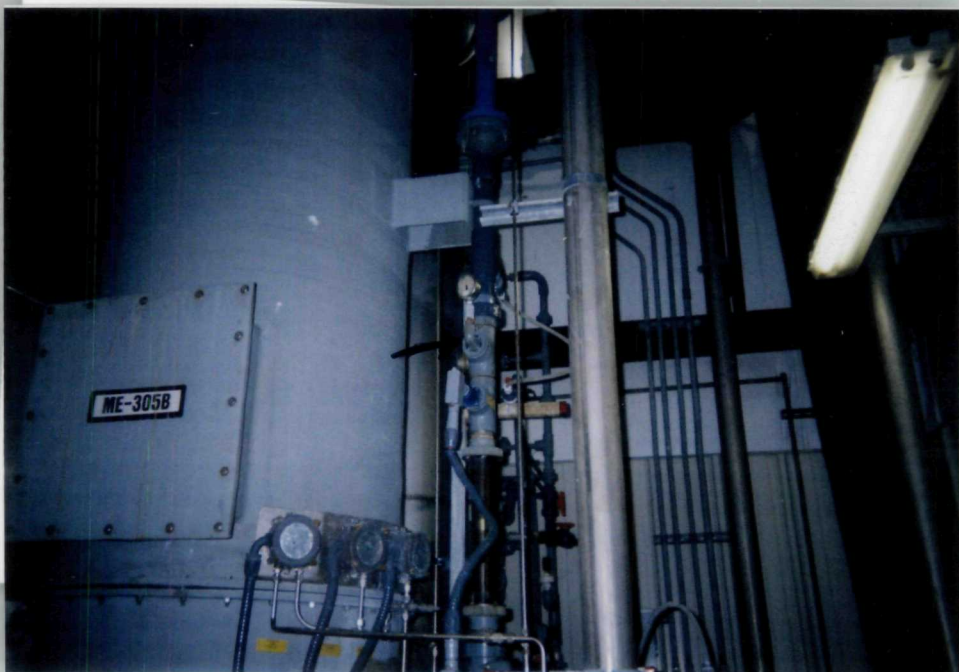
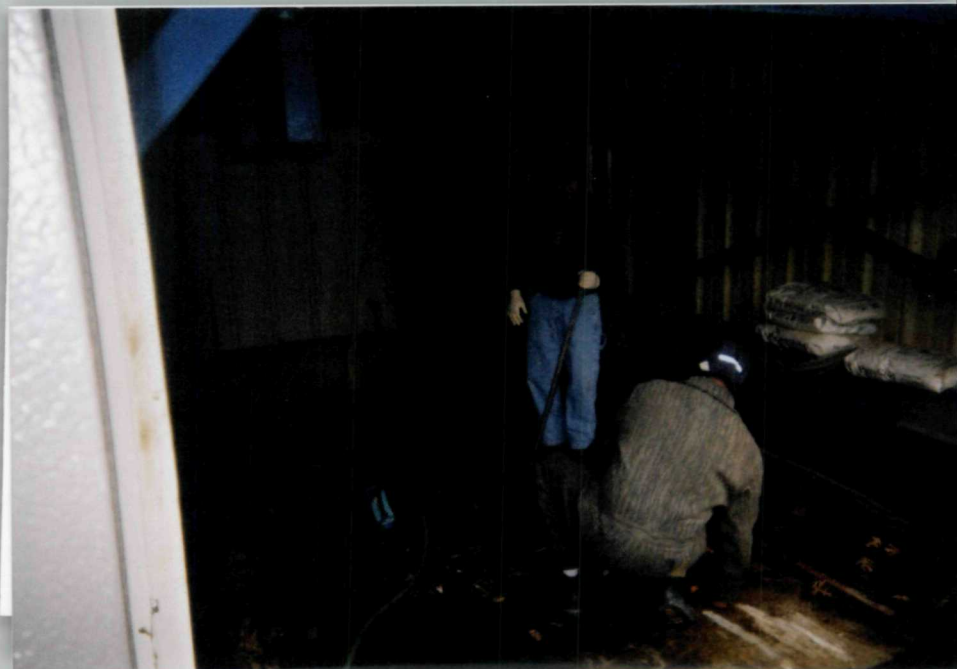
0920 Photo 83-17 looking S & up at repaired Austre feed line at thermox 2.

Site: American Chemical Service, Inc.
Proj. #: 44728 AES [46526 RAC]
Roll: 83 Photo #17
Date: 3-21-06 Time: 0920
Photographer: Larry Campbell
Description: Photo facing south and up showing repaired
caustic line on thermox 2

Compare with Roll 83 Photo #08

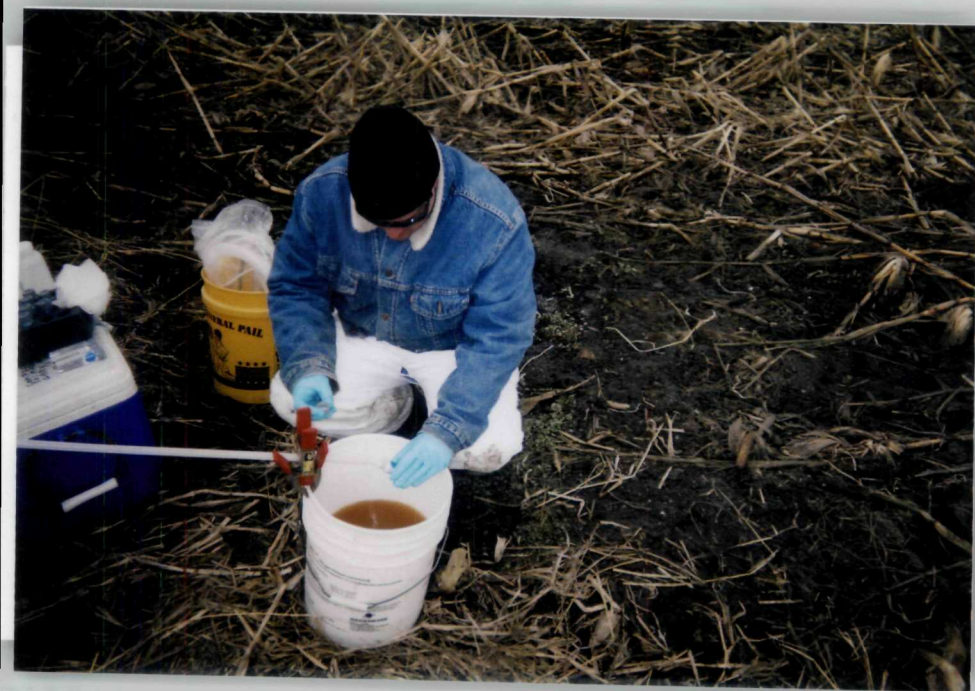
Site: American Chemical Service, Inc.
Proj. #: 44728 AES [46526 RAC]
Roll: 83 Photo #21
Date: 3-21-06 Time: 1220
Photographer: Larry Campbell
Description: Photo facing south showing MWH
collecting groundwater sample from MW42.

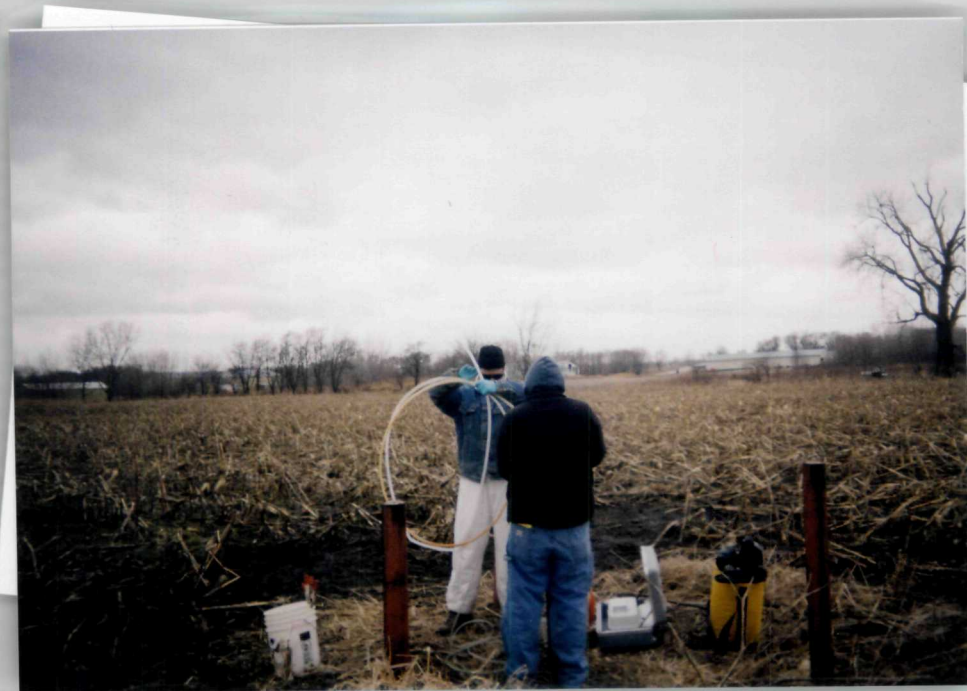
Site: American Chemical Service, Inc.
Proj. #: 44728 AES [46526 RAC]
Roll: 83 Photo #22
Date: 3-21-06 Time: 1230
Photographer: Larry Campbell
Description: Photo facing northwest showing MWH
removing pump from MW42. Looking
toward GWTP from farthest southeast
monitoring well.

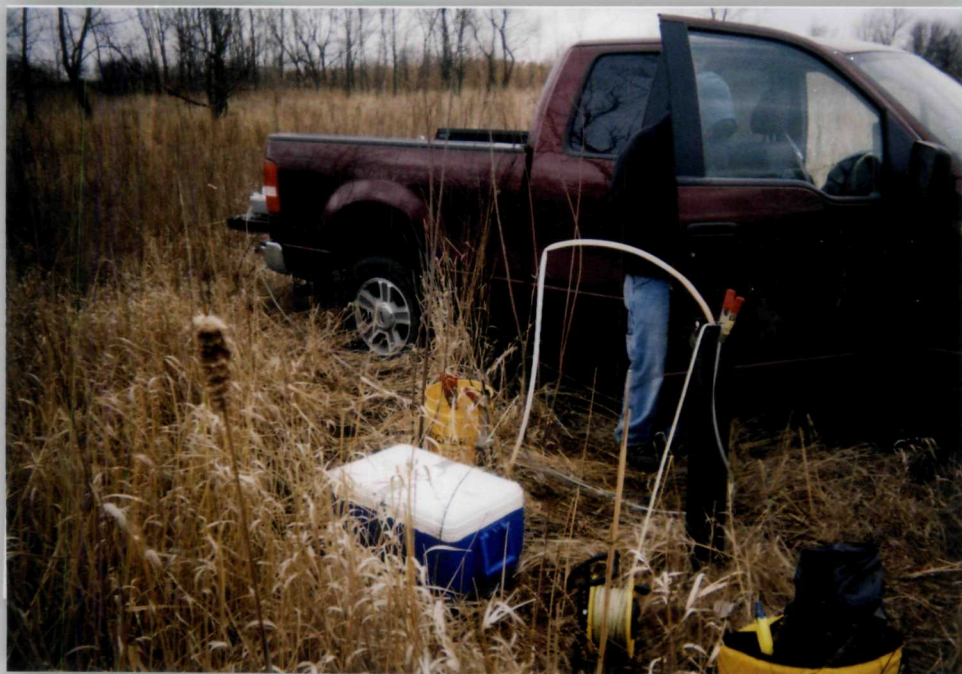
Site: American Chemical Service, Inc.
 Proj. #: 44728 AES [46526 RAC]
 Roll: 83 Photo #23
 Date: 3-21-06 Time: 1520
 Photographer: Larry Campbell
 Description: Photo facing south showing MWH purging
 MW44 before sampling.

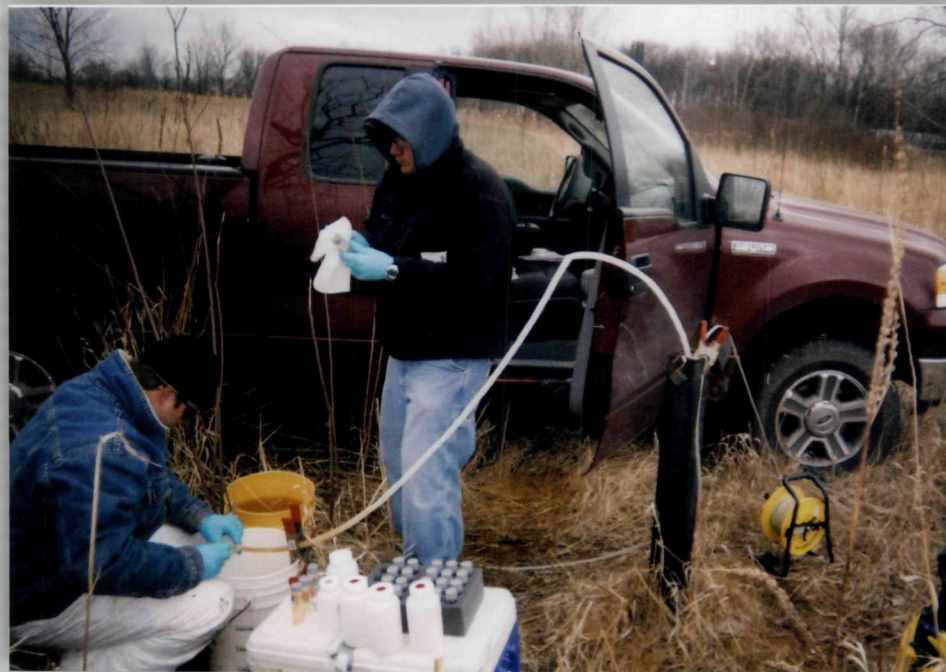
Site: American Chemical Service, Inc.
 Proj. #: 44728 AES [46526 RAC]
 Roll: 83 Photo #24
 Date: 3-21-06 Time: 1600
 Photographer: Larry Campbell
 Description: Photo facing south showing MWH
 collecting groundwater sample from MW44.

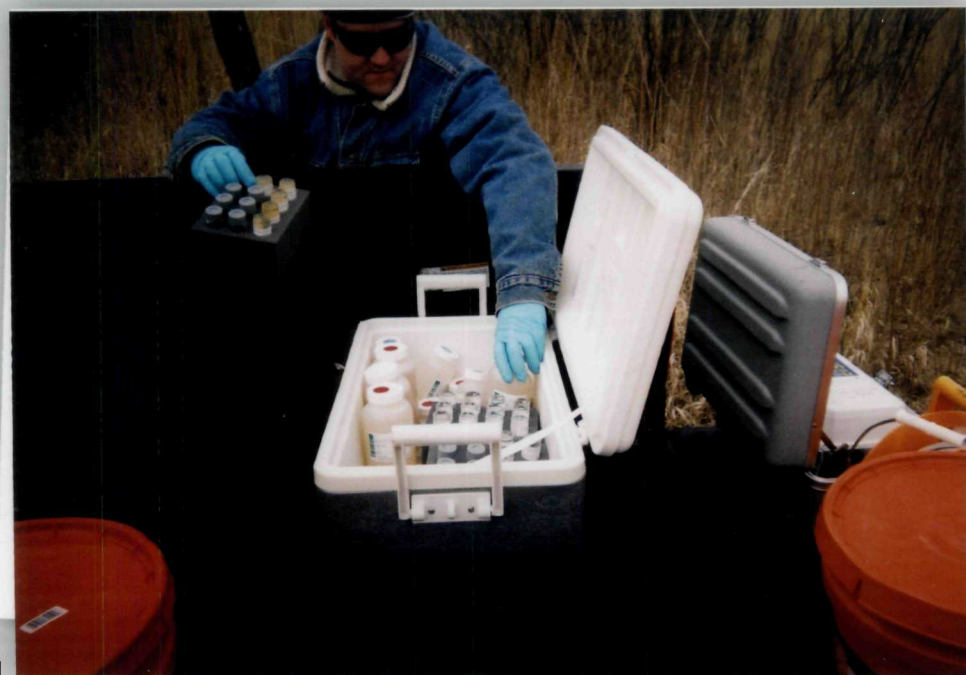
Site: American Chemical Service, Inc.
Proj. #: 44728 AES [46526 RAC]
Roll: 83 Photo #25
Date: 3-21-06 Time: 1605
Photographer: Larry Campbell
Description: Photo facing north showing MWH storing collected samples in cooler.

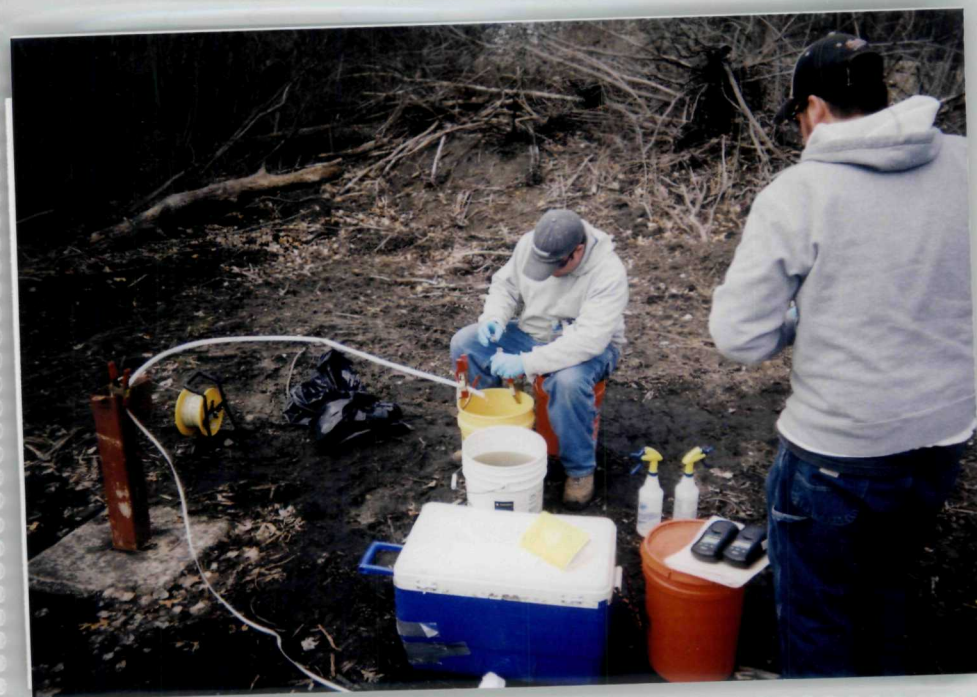
Site: American Chemical Service, Inc.
Proj. #: 44728 AES [46526 RAC]
Roll: 83 Photo #26
Date: 3-23-06 Time: 1430
Photographer: Larry Campbell
Description: Photo facing north showing MWH collecting VOC sample from lower aquifer well LA12 near northern property boundary.

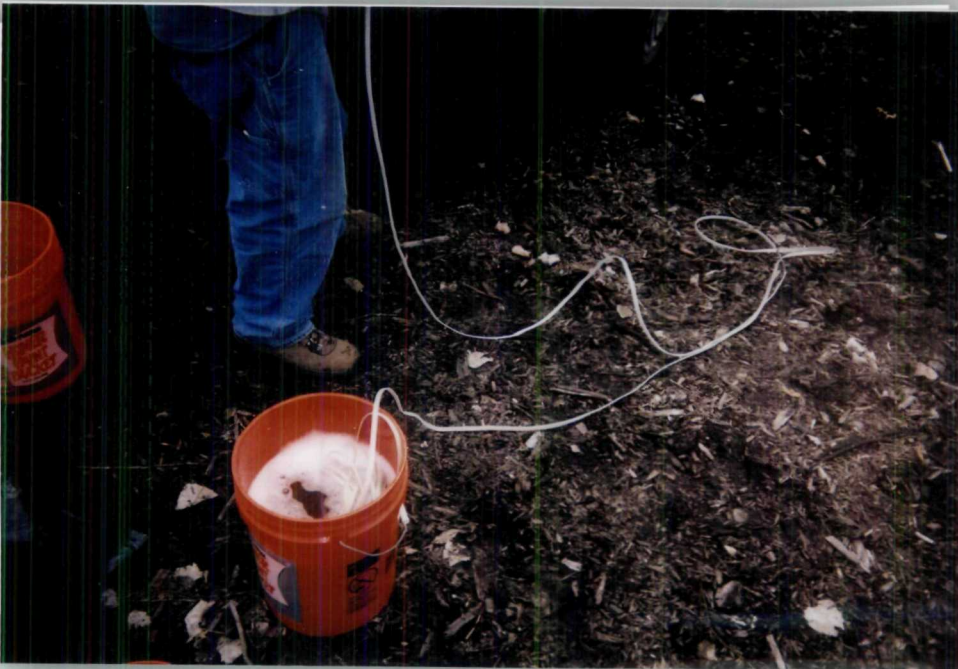
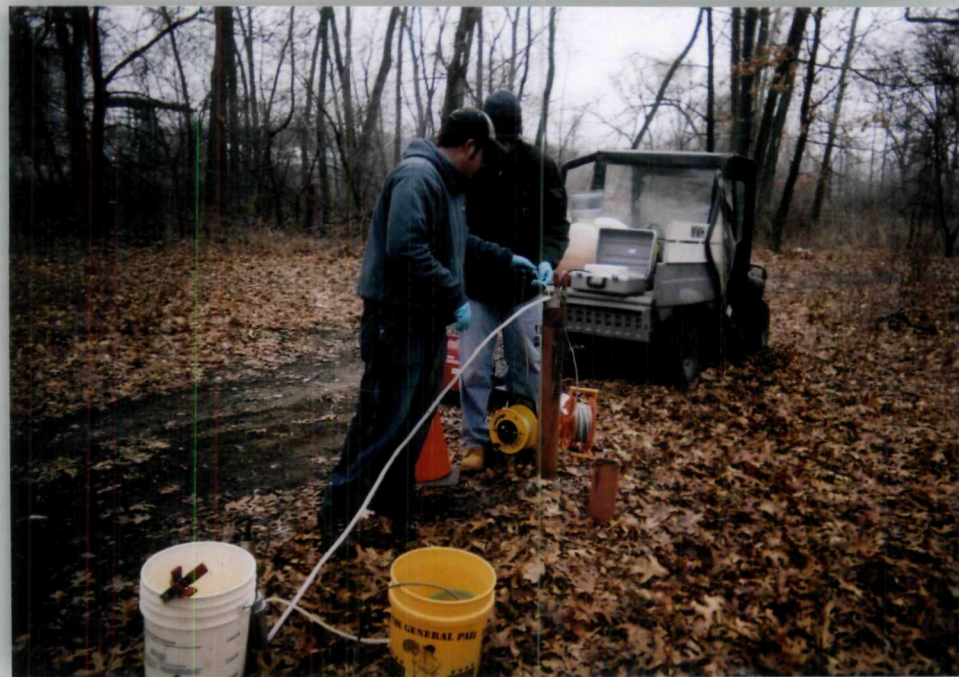
Site: American Chemical Service, Inc.
 Proj. #: 44728 AES [46526 RAC]
 Roll: 83 Photo #27
 Date: 3-23-06 Time: 1442
 Photographer: Larry Campbell
 Description: Photo facing down into bucket of Alconox
 where peristaltic pump is being
 decontaminated.

Site: American Chemical Service, Inc.
 Proj. #: 44728 AES [46526 RAC]
 Roll: 84 Photo #1
 Date: 3-28-06 Time: 0953
 Photographer: Larry Campbell
 Description: Photo facing southeast showing MWH
 measuring water level prior to purging water
 from MW09R.

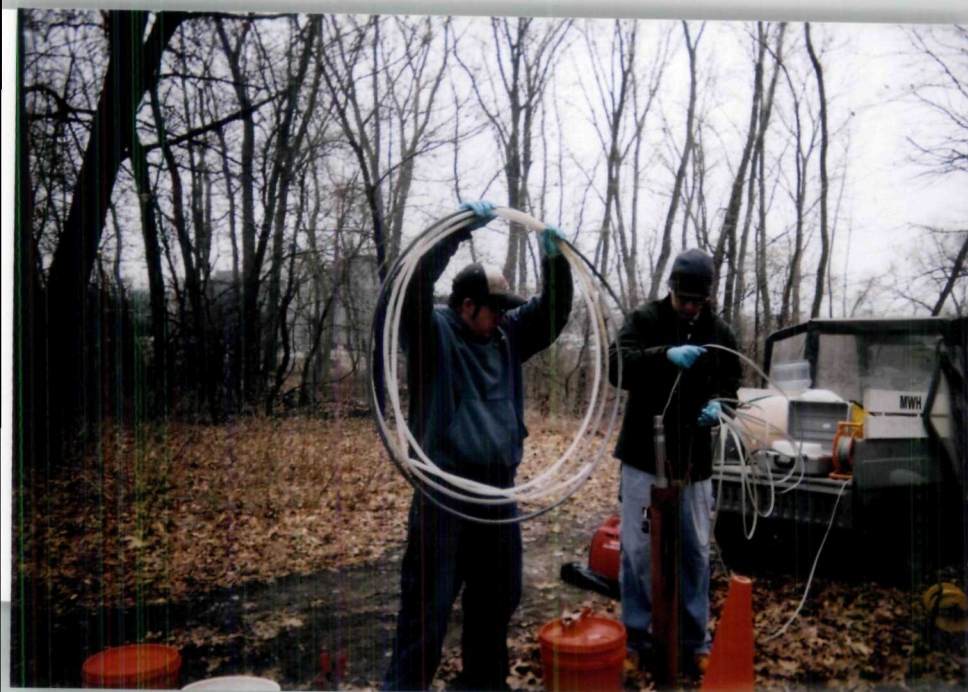
Site: American Chemical Service, Inc.
 Proj. #: 44728 AES [46526 RAC]
 Roll: 84 Photo #4
 Date: 3-28-06 Time: 1031
 Photographer: Larry Campbell
 Description: Photo facing southeast showing MWH
 removing pump from MW09R.

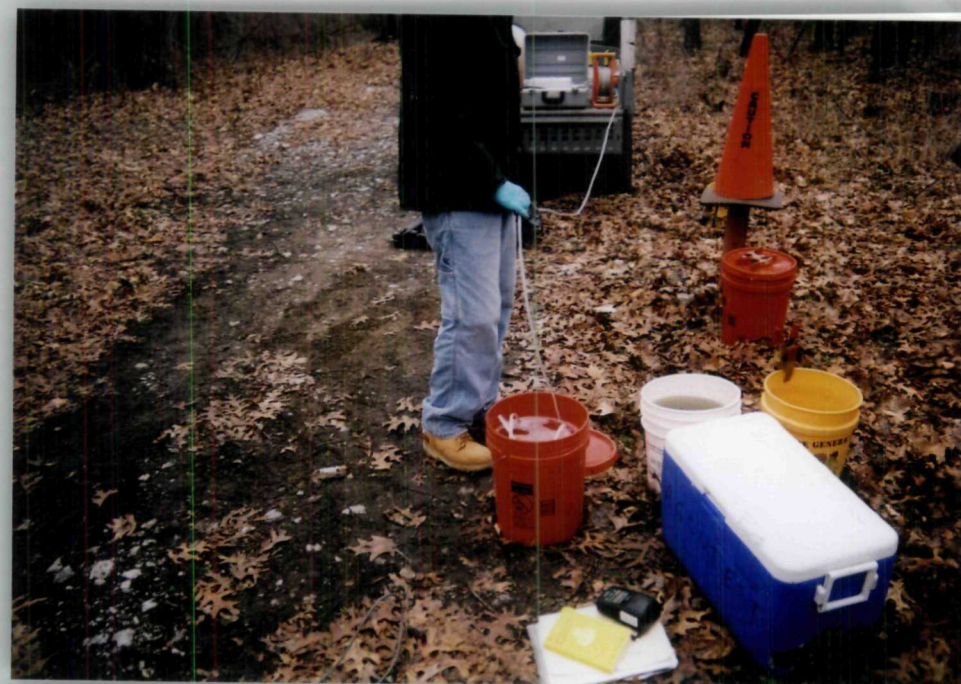
Site: American Chemical Service, Inc.
 Proj. #: 44728 AES [46526 RAC]
 Roll: 84 Photo #5
 Date: 3-28-06 Time: 1034
 Photographer: Larry Campbell
 Description: Photo facing south showing MWH
 decontaminating pump and cable after
 sampling MW09R. This is the last of 36
 wells sampled during this sampling event.
